## Environmental Control System Decontamination

Reference: 21.00.00018 First Issue Date: 07-NOV-2013 Last Publication Date:  
08-NOV-2013

ATA: 21-00

A/C Type : A318 ; A319 ; A320 ; A321

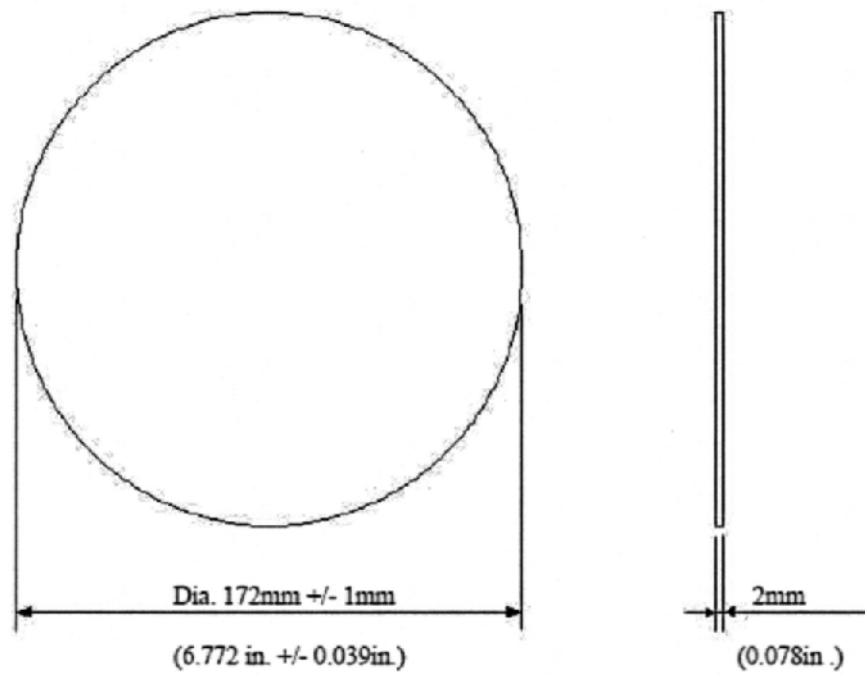
Figure 1. Blanking plates

preventing further downstream contamination it is necessary to remove the pack outlet

duct and blank the downstream ducting (see figure 1). This allows the contaminated air to

exit the aircraft via the pack bay and facilitates inspection of the pack condenser to

Two blanking caps are necessary to perform the pack decontamination procedure, described in paragraph 3.2.2. They should be locally manufactured in accordance with the sketch given in figure

1 from any light alloy sheet metal.

Material: Light alloy  
Two blanking plates required

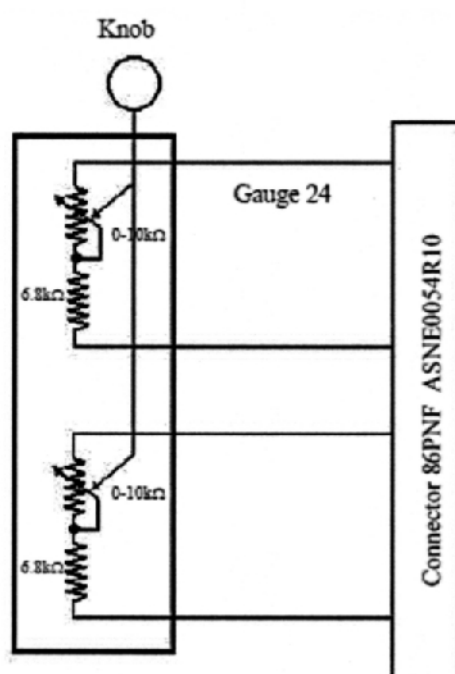
Figure 2. Temperature simulating device

minutes with temperatures selected full hot. In the event of high ambient temperatures (above 24°C/75°F) it will not be possible to establish a pack heating demand. It will therefore be necessary to install temperature sensor simulation devices (see figure 2) in

place of the three zone temperature sensors FIN 21HK, 22HK and 23HK.

Three temperature simulating devices are required to perform decontamination in high ambient

temperatures. These should be locally manufactured in accordance with the schematic given in

figure 2 using readily available industrial standard electrical components.
